Failure of a Rock Slope Ten Years after Excavation

Abstract: In the present study, a rock cut slope in Chongqing of China, which failed suddenly about ten years after excavation, was reported. The survey results after failure indicated that the rock masses of the rock slope were highly fractured and heavily weathered, the critical slip surface was composed of three connected discontinuities from the toe to top of slope. The factors resulting in the failure of rock slope were mainly initial excavation and weathering process. The initial excavation removed original supporting role of the excavated rock masses at the toe of the slope to the upper unexcavated rock masses, and broken the original ground stress balance. The physical and chemical weathering after the initial excavation cracked progressively the rock masses, deteriorated the mechanic properties of the rock masses, and changed the stresses and strains in the rock slope. The stability of high artificial rock slope during operation should be paid attention to. The characteristics of geological structure, unloading induced by excavation, and weathering have important effects on the evolution for deformation of artificial rock

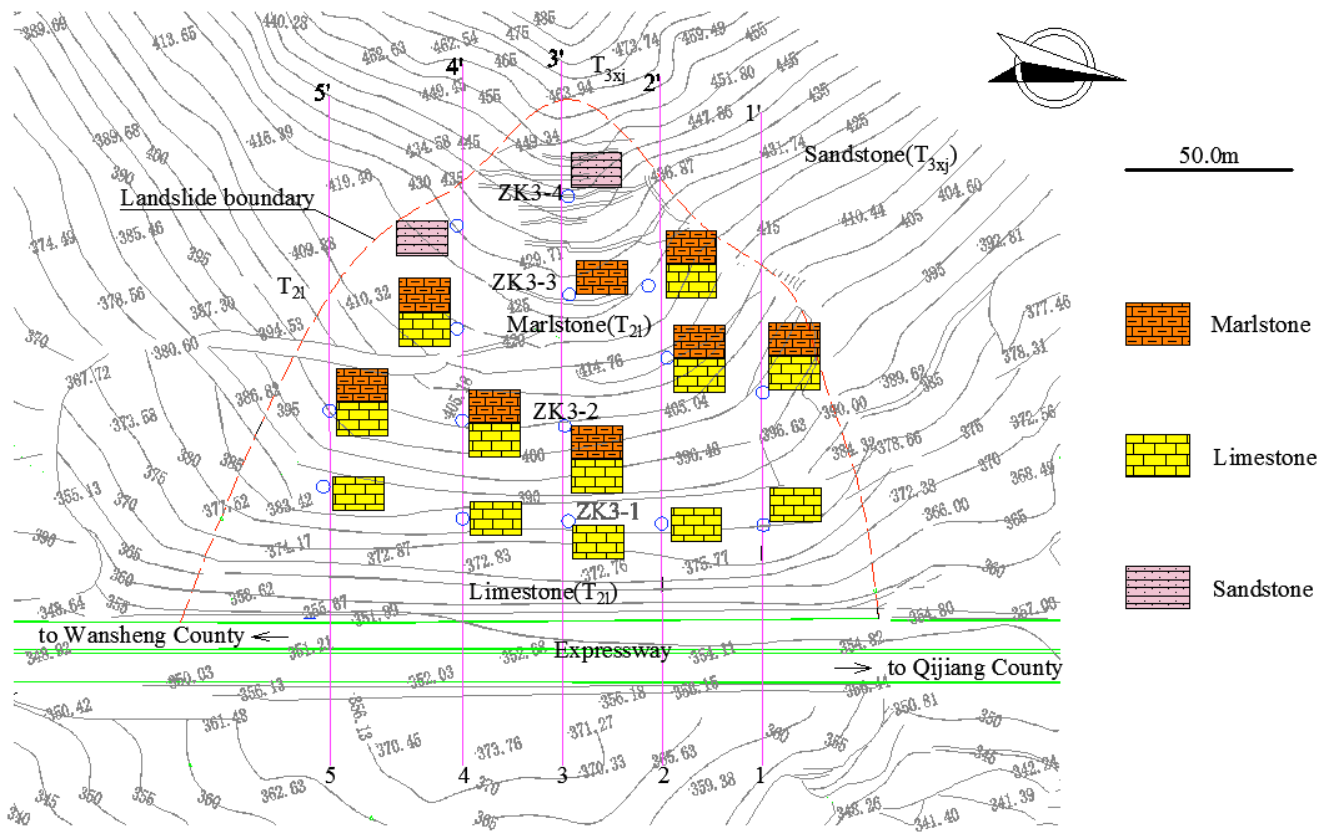
Figure 1: Engineering geological plan of the landslide.

The geological properties of this high artificial rock slope were surveyed in detail after failure. Figure 1 and 2 show that the strata in the rock slope were thin top-layer loam formed during Quaternary Holocene period (T_4), sandstone layers formed in Upper Triassic (T_3),

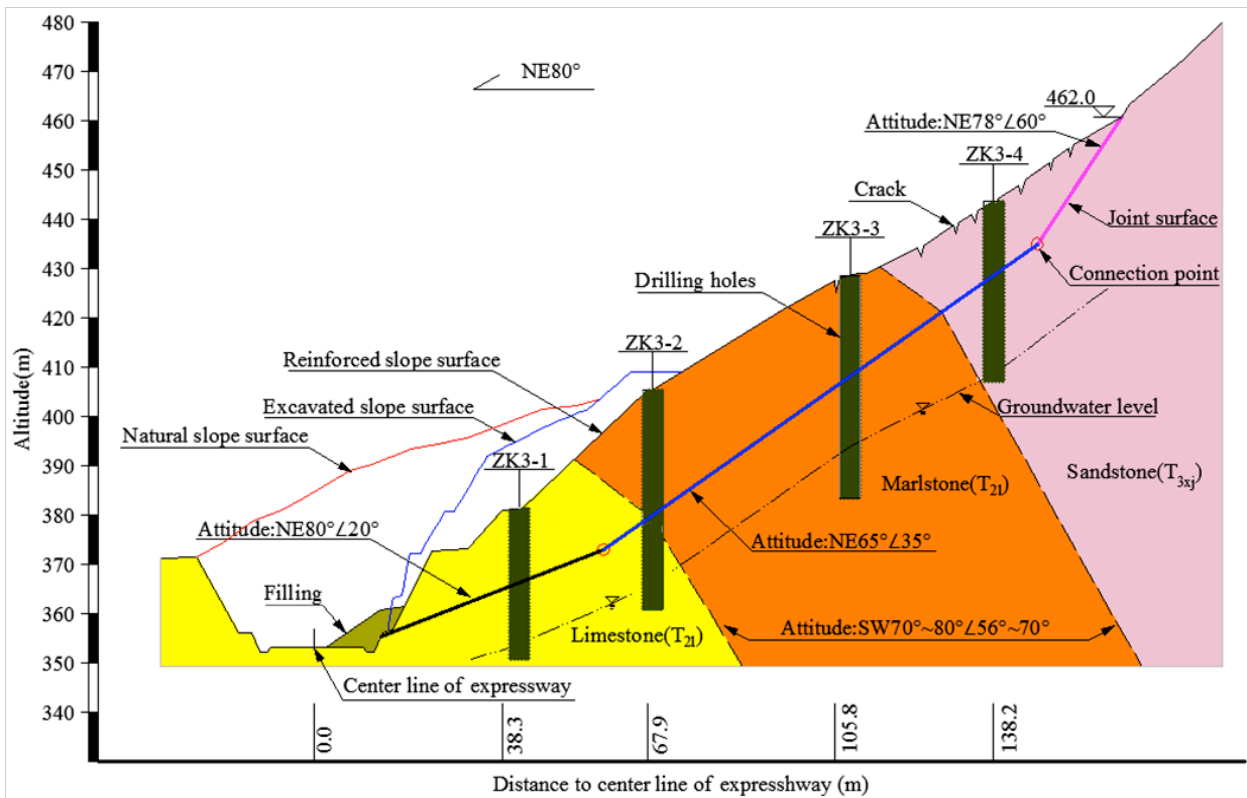
Figure 2: Engineering geological longitudinal section #3-3'.

According to Figure 2, the critical slip surface of the landslide was composed of three connected discontinuities from the toe to top of the slope. The results of geological drilling indicated that the sandstone, limestone and marlstone layers in the rock cut slope were weathered moderately to heavily. Some small cavities were present in limestone layers and the rock masses were highly fractured.

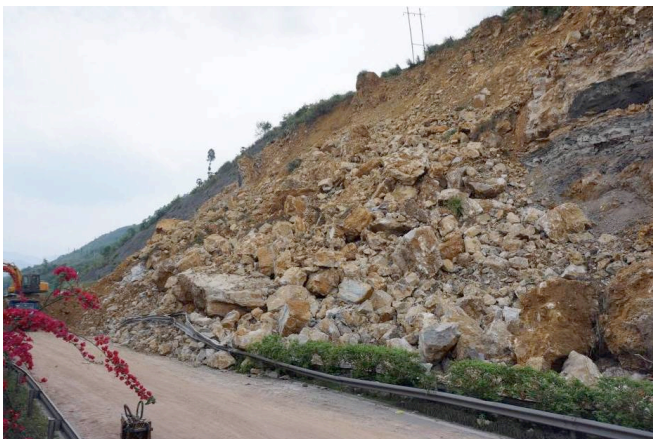
At about 12 o'clock on May 4, 2013, the rock cut slope was collapsed suddenly from its first or second secondary slope near the toe of slope, and the traffic of the expressway was stopped (Figure 3). Several long and open cracks were detected on the mountain slope far away from the top of cut slope. In order to avoid further failure, partly superficial unstable rock masses were excavated to reduce driving forces (Figure 4), and some excavated rock blocks were filled at the toe of slope to increase resisting forces (Figure 2). Figure 4 shows the photo of the whole slope after excavating superficial unstable materials. The horizontal width of the unstable slope or landslide, which was the length

Figure 3: Photo of rock slope after failure (on May 4, 2013).

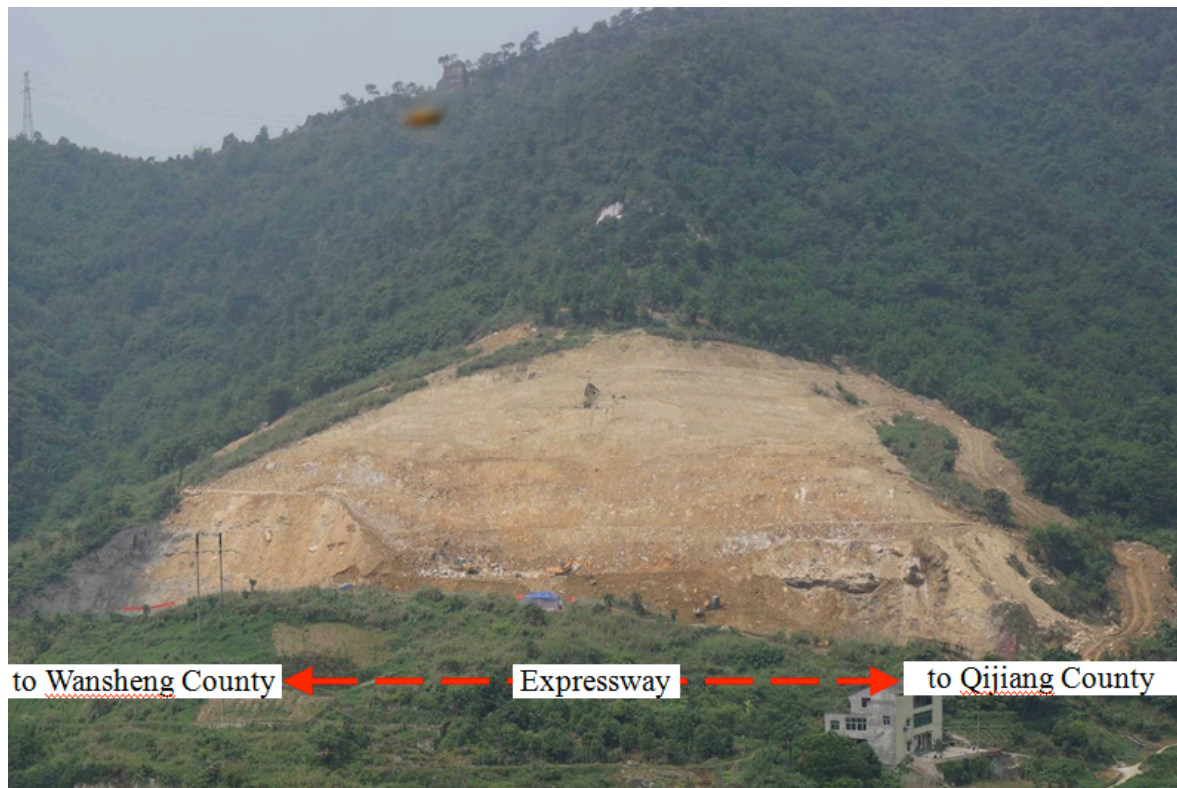
Figure 4: Photo of landslide after excavating superficial unstable materials.

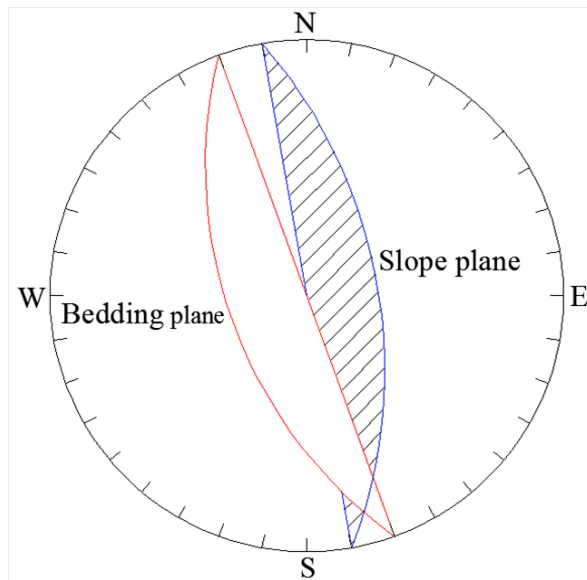
Based on the above analysis, the average attitude of the whole rock cut slope is $NE80^\circ/59^\circ$, and the bed rock attitude could be chosen as $SW70^\circ/56^\circ$. Stereo-analytical map can be made as Figure 5. Obviously, from this point of view, the high artificial rock slope is very stable, not easy to slide. But it had actually slipped.

Figure 5: Stereographic projection map.

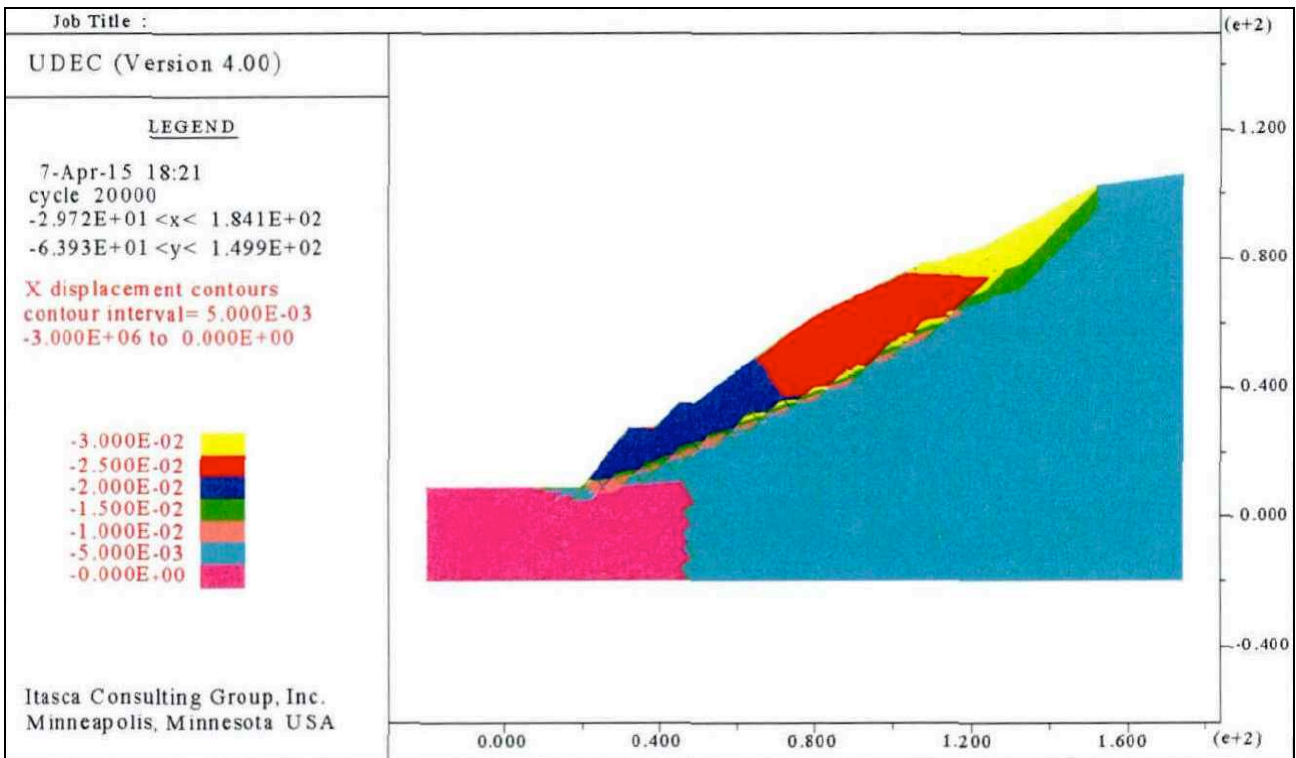
Figure 6: The horizontal displacement cloud image.

According to Figure 6, under the action of unloading rebound and creep, the strong weathered layer in the middle and upper part of the weak interlayer of the reserved slope body have obvious downward dislocation deformation, the middle and lower of the reserved slope rock masses are squeezed to a certain extent. At the foot of the reserved slope, there are squeezing phenomenon and bulging phenomenon. This indicates that the instability of high artificial rock slope is related to the unloading action caused by excavation.

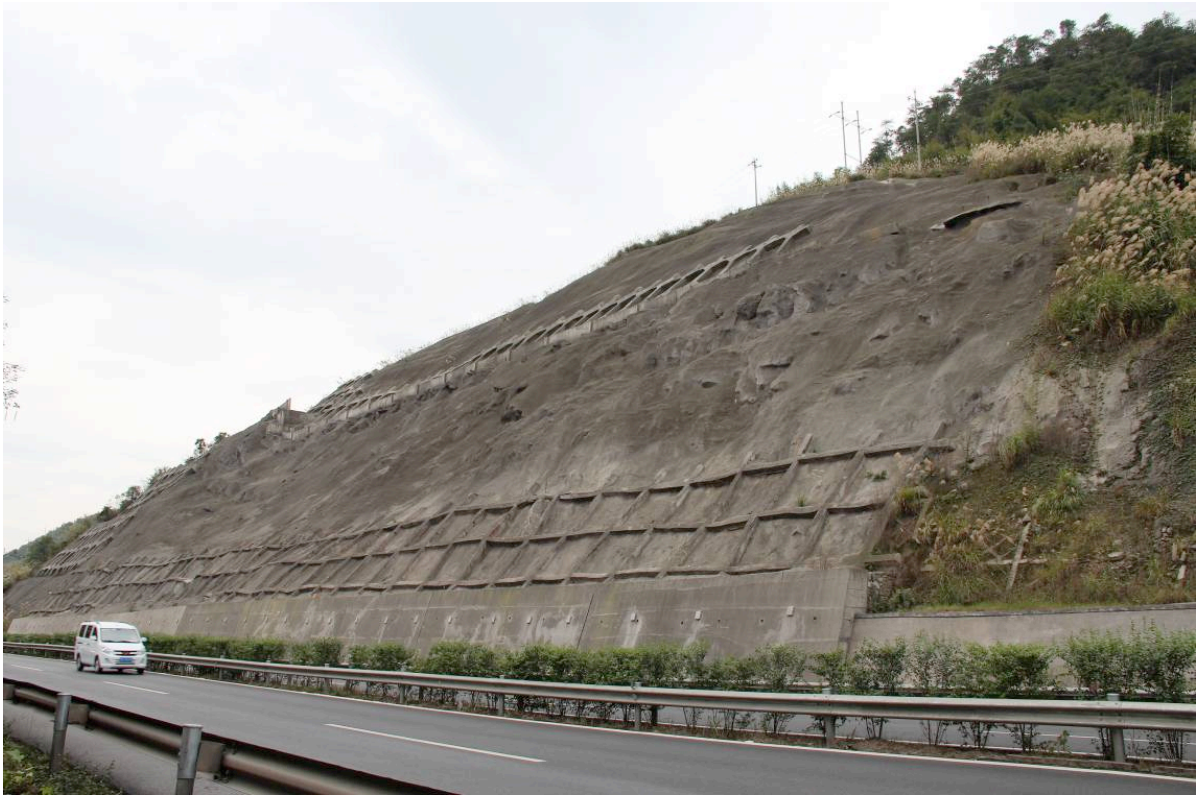
The stability degree of the slope after reinforcement must meet the safety requirement. According to Chinese specifications for design of highway subgrades JTG D30-2004 (MOHURD 2004), the required factor of safety is 1.20 to 1.30 in natural states, and 1.10 to 1.20 under saturated conditions. The design methods of the piles and anchors suggested by MOHURD (2004) and described by Wang et al. (2014) were used. The stabilization treatments of this high artificial rock slope have been carried out about three years ago. Now, this high artificial rock slope is stable (Figure 8).

Figure 8: Photo of rock slope after near 3 years since stabilization.
