# Structural Stability Assessment of a Masonry Chimney Subjected to Shocks by Vibration Measurements

F. Telch<sup>1</sup>, G. Lacidogna<sup>1,\*</sup> and O. Rösch<sup>2</sup>

<sup>1</sup>Department of Structural, Geotechnical and Building Engineering, Politecnico di Torino, 10129 Torino, Italy <sup>2</sup>Materials Testing and Research Institute, Karlsruhe Institute of Technology, 76131 Karlsruhe, Germany

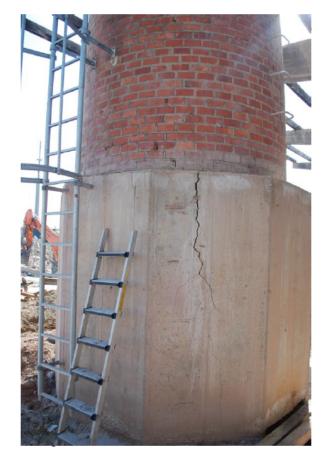
As previously described, there are several distinct cracks on the reinforced concrete cuff and at various locations above it. Striking is a pronounced vertical crack with a width of about 10 mm (Figure 3). The cracks indicate that the ring tensile strength was exceeded at some point during the time. Evidently, the chimney also has an oblique position in the direction of the pronounced crack. Possibly, the above-mentioned mobile radio system, which was attached to this side, caused the formation of vertical cracks.

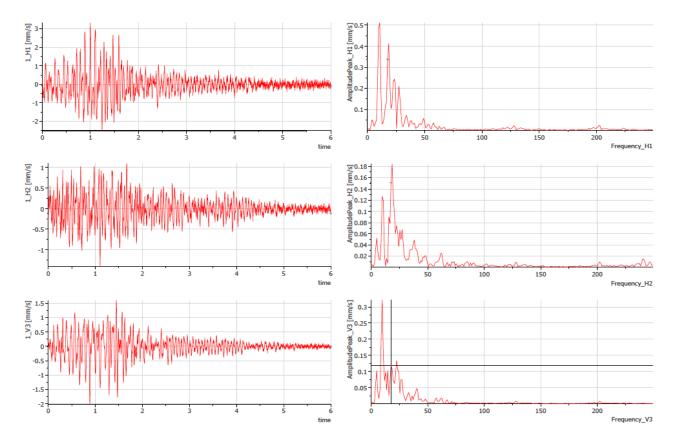
In Figure **6**, for example, the event of June 7 at 11:57 am is shown. In this case, the oscillation speed is exceeded in horizontal direction H1. Considering the direction H1 with  $v_x = 3.304$  mm/s and only the vibration itself (Figure **6**, top left and right sides), the decisive excitation frequency of 10.74 Hz is obtained. According to Eq. (4), the following oscillation speed can be determined:

Figure 6: Event from June 7, 2017 at 11:57 am with the frequency spectrum on the right side.

$$v_{max,new} = 0.125 \cdot 10.74 + 1.75 = 3.093 \, mm/s < 3.304 \, mm/s$$
(7)

As can be seen, the existing oscillation speed is higher than the limit value, even if the difference is approximately 7% (= 0.211 mm/s). So further investigations must be carried out. This calculation method has been performed for all stored events and the results are listed in Table **2**.

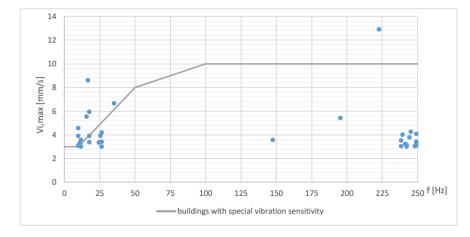
In addition, it can be seen in Figure **7** that three points do not fall into these two cases: on May 30, at 07:57 am, May 23 at 09:37 am, and July 18 at 08:03

am, but it was not possible to detect the source which was the cause.

Figure 7: Graphic representation of the events.

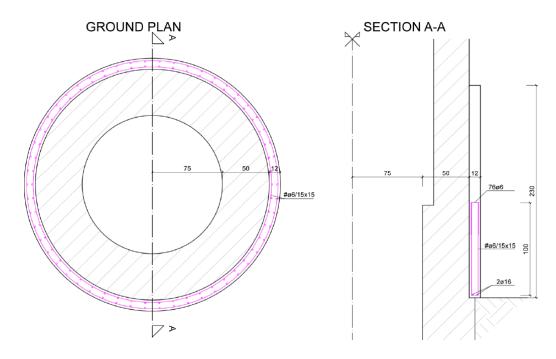
Figure 10: Detail of the concrete cuff.

Due to existing geometry, not only compressive stresses but also circumferential tensile stresses occur, which should not exceed the permissible tensile strength. The fracture plane is perpendicular to the horizontal joints. However, as previously described and illustrated in Figure **3**, at the base, thus at the reinforced concrete cuff and at the masonry wall, cracks of several millimetres were found. These must be taken into account in the investigations, which means, tensile strength of the masonry is neglected. The reinforced concrete cuff is cracked. Thus, only the reinforcement can absorb the tensile forces in the circumferential direction. According to implementation plan [23], and as shown in Figure **10**, a welded steel mesh ø6/15x15 cm, with  $a_s = 1.88$  cm<sup>2</sup>/m, was installed in the 12 cm thick cuff by bending it in a U-shape. This results in two layers with reinforcement. At the foot 2ø16 (A<sub>s</sub> = 4.02 cm<sup>2</sup>) were collocated. A reinforcing steel Bst500S with a characteristic yield strength of f<sub>yk</sub> = 500 MPa was used. Considering a safety factor equal to 1.15, the yield strength to be used is f<sub>yd</sub> = 435 MPa. Because the existing reinforcement cross-sectional area is A<sub>s</sub> = 778 mm<sup>2</sup>, it can absorb a tensile force of 338 kN.

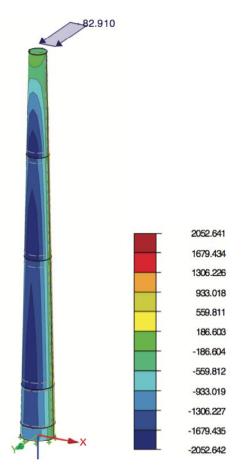
In Figure **11**, the 3D model is represented. It shows the compressive stresses due to the third natural frequency and the vibration of June, 07 at 11:57 am. Attention is drawn to the fact that the force in the model was entered as a line load, therefore the forces F were divided by the diameter of the chimney head. No single concentrated force was applied, as this does not give a truthful deformation, especially around the applied force zone. From the diagram of Figure **11**, the stress was obtained. This operation was used for the other three modes of oscillation, and using Eq. (9) the effective compressive stress due to vibration was determined.

By using Eq. (9), a compressive stress of 2.3 MPa, and a tensile force of 168 kN, at the chimney base are obtained, which respectively are lower than the

masonry strength (4.8 MPa), and the steel plastic axial force (338 kN).

Figure 11: 3D – Model with the compressive stresses induced due the third natural frequency of the vibration on June, 07 at 11:57 am.

As can be seen, the existing loads do not exceed the associated admissible values, and thus it is proved that this event did not harm to the chimney.

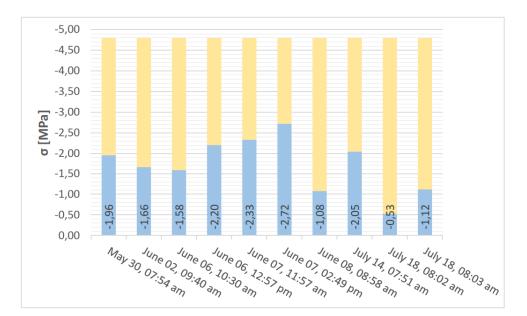
In Figures **12** and **13**, the compressive stress and the tensile forces are shown. As can be seen, the permissible compressive stress of 4.8 MPa and the existing permissible tensile force of 338 kN were never reached. The most stressful event occurred on June 07, at 02:49 pm. In this case the oscillation speed reached in the horizontal direction H1 5.951 mm/s. Removing this event, one might assume that there is a relation between the oscillation speed and strength but instead are only the spectral accelerations factors that affect stress. The connection would be the lower the vibration velocity, the higher the loads.

Figure 12: Existing compressive stress (blue), missing compressive stress to reach the permissible one (yellow).

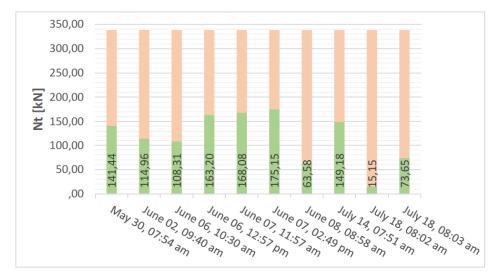
Figure 13: Existing tensile force (green), missing tensile force to reach the permissible one (grey).
