# **International Journal of Architectural**

# Tracing the Historical Development of Architecture in Cyprus and its Resilience to Seismic Hazards

Georgios Xekalakis<sup>1</sup> and Petros Christou<sup>1,2,\*</sup>

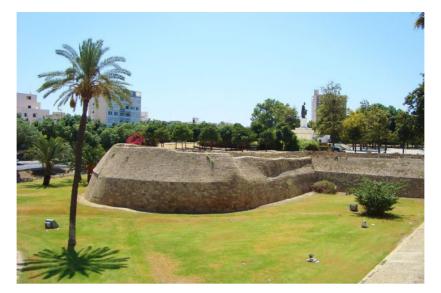
Figure 1: The Venetian Walls of Nicosia (source, A. Savin own work).

The Venetian Walls of Nicosia (Fig. **1**) are a series of defensive walls that surround the old city of Nicosia, the capital of Cyprus. The walls are considered to be one of the finest examples of Renaissance military architecture in the Eastern Mediterranean region. The Venetian Walls of Nicosia are characterized by their imposing size and strength. The walls are up to 20 meters high and are made of stone, with bastions and towers strategically placed along their length. The walls are almost 5 kilometers long and have three gates: the Paphos Gate in the west, the Famagusta Gate in the east, and the Kyrenia Gate in the north. The walls are built in a polygonal shape, following the contours of the ground. This means that the walls have a series of angles and bends, which makes it more difficult for attackers to approach them directly. The walls are also reinforced with various defensive features, such as moats, glacis, and ravelins, which further strengthen their defensive capabilities.

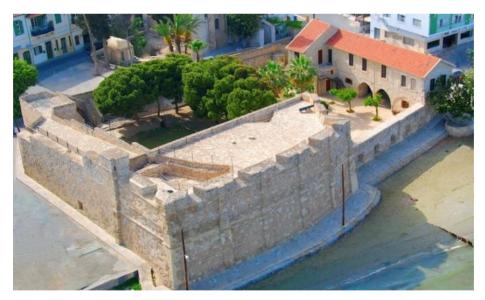
Figure 2: Larnaca Castle [17].

Larnaca's Castle (Fig. **2**), also known as Larnaca Fort, is a medieval castle located on the southern coast of Cyprus [17]. The castle is characterized by its sturdy, rectangular structure, which is built from limestone blocks. The walls of the castle are up to 2.5 meters thick, and the entire structure is surrounded by a moat, which was once filled with sea water. The castle has two floors, with a central courtyard that is surrounded by various rooms and halls.

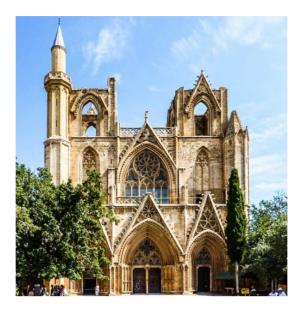
Figure 3: Church of St. Nicholas in Famagusta [18].

The Church of St. Nicholas (Fig. **3**) is a medieval church located in Famagusta, a historic city on the eastern coast of Cyprus [18]. The church was built in the 14th century and is considered to be one of the finest examples of Gothic architecture on the island. The church is characterized by its tall, slender proportions and its intricate decorative features. The exterior of the church is built from local limestone blocks and is decorated with a variety of Gothic motifs, including pointed arches, tracery, and quatrefoil shapes. One of the most distinctive features of the Church of St. Nicholas is its bell tower, which is located at the front of the church. The bell tower is octagonal in

shape and is topped with a pointed spire. The tower is decorated with a variety of ornate carvings and has several openings for the bells.

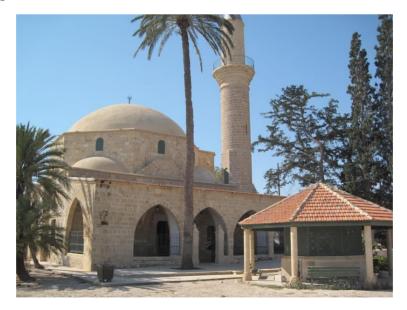
Hala Sultan Tekke (Fig. 4) is a historic mosque located in the city of Larnaca, Cyprus [19]. The mosque is built on the west bank of Larnaca Salt Lake and is considered one of the most important holy places in the Islamic world. The mosque is built on a rectangular foundation made of local stone and its walls are made of thick stone blocks and have no windows. This is because Islamic tradition prohibits the depiction of living beings in religious buildings. The building has a central dome, which is larger than the four smaller domes located at each corner of the building. The domes are made of brick and covered with red tiles. The interior of the mosque is supported by columns made of stone. The columns are arranged in a square pattern around the central dome. The mosque has a large rectangular courtyard, which is surrounded by a low wall. The courtyard is paved with stones and is used for prayer and other religious activities.

**Figure 4:** The mosque has a large rectangular courtyard, which is surrounded by a low wall. The courtyard is paved with stones and is used for prayer and other religious activities [19].

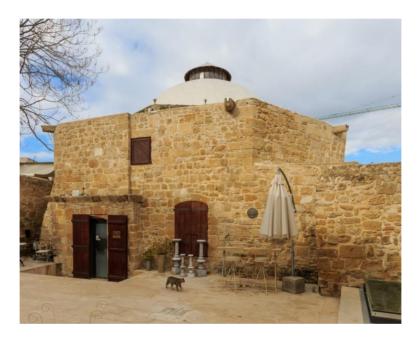
Figure 5: Hamam Omerye, Nicosia (source, A. Savin own work).

Hamam Omerye (Fig. **5**) is a historical public bathhouse located in the old city of Nicosia, Cyprus [20]. It was built during the Ottoman era in the 16th century and has since been renovated and restored multiple times. The hamam has many structural characteristics that are unique and distinctive. It is primarily constructed of stone masonry, which is a durable and sturdy building material. The Hamam Omerye has several barrel-vaulted ceilings, which are created by curving a series of arches. The barrel-vaulted ceilings provide structural support and help distribute the weight of the building. The roof is supported by timber roof trusses, which are triangular-shaped structures, made of wood. The timber roof trusses help distribute the weight of the roof and provide structural stability. The walls are reinforced with buttresses, which are projecting support structures that help distribute the weight of the roof. The Hamam Omerye has several stone columns that support the vaulted ceilings. The columns are constructed of stone blocks, which are stacked on top of one another and held together with mortar. It has several arched openings, which are created by curving a series of stones or bricks. The arched openings help distribute the weight of the walls and provide structural stability and inside it has an underground cistern that collects rainwater. The cistern is constructed of stone and is reinforced with arches and buttresses.

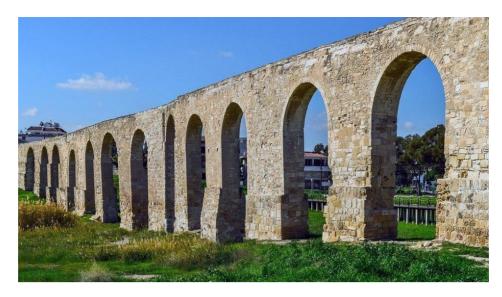
Figure 6: Kamares Aqueduct, Larnaka (source, A. Savin own work).

The Kamares Aqueduct, also known as the Bekir Pasha Aqueduct (Fig. **6**), is a historic structure in Larnaca, Cyprus that was built in the 18th century [21]. It was designed to bring water to the city from a nearby spring and is considered a remarkable engineering feat of the time. The aqueduct is constructed of a series of arches, which are curved structures that support the weight of the aqueduct and distribute the water flow evenly. The arches are constructed of brick and are arranged in a linear pattern. The arches are supported by cut-stone piers, which are vertical columns of stone that provide structural support and stability. The piers are spaced evenly along the length of the aqueduct and are constructed of the same type of stone as the arches. The arches and piers are held together with mortar, which is a type of cement that is used to bond the bricks and stones together. The aqueduct features a stone channel that runs along the top of the arches. This channel was designed to carry the water from the spring to the city and is wide enough to allow for easy maintenance and repair. The aqueduct has a stone parapet, which is a low wall that runs along the top of the arches. The parapet is designed to provide additional stability to the aqueduct and to prevent people from falling off the structure. At the end of the aqueduct, there is a water basin that was used to collect the water from the spring. The basin is constructed of stone and is designed to hold a large volume of water.

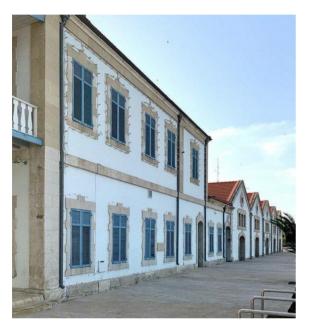
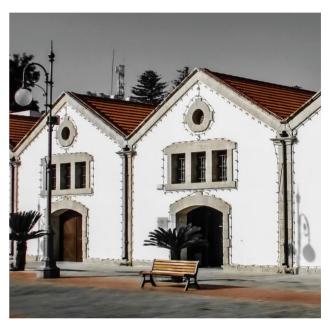
Figure 8: Municipal Art Gallery and Museum of Paleontology, Larnaca [23].

The Municipal Art Gallery and Museum of Paleontology (Fig. 8) is a historic building located in the city of Larnaca, Cyprus. The building was constructed around 1881 during the period of British colonial rule and was originally used as a government building [23]. The aforementioned, it is a masonry building, which means its structural elements are made primarily of stone and brick. The load-bearing masonry walls are the most significant structural element of the building, providing support and stability to the floors and roof. The exterior walls are constructed of local limestone, which is a durable and commonly used material in Cyprus. The walls are several feet thick in some places and are designed to resist lateral loads and provide structural stability. The roof of the building is a traditional pitched roof, covered with terracotta tiles laid in a herringbone pattern which is supported by timber trusses, which span between the load-bearing walls. Inside the building, the most significant structural element is the central staircase, which is made of marble and features decorative detailing. The staircase is supported by load-bearing walls and reinforced with steel elements to provide additional stability.

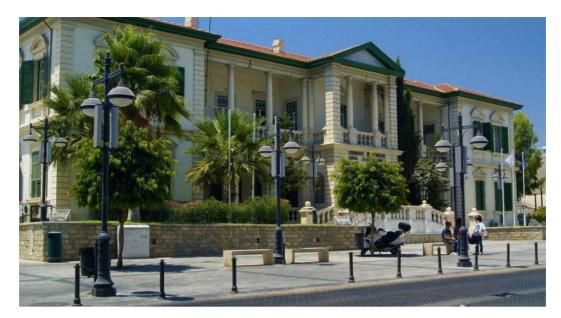
Figure 9: Administration Offices, Limassol [24].

The District Administration Offices in Limassol (Fig. **9**) is a mid-century modernist building constructed in the 1960s [24]. The building's structural elements are primarily made of reinforced concrete, which was a popular construction material during the period of its construction. The building's structural design features a series of concrete columns and beams that support the floors and roof. The columns are arranged in a regular grid, creating a rhythm that is consistent throughout the building. The building's floor slabs are made of precast concrete panels that are supported by the concrete beams. The roof of the building is flat and is supported by a series of concrete beams, which span between the columns. The roof is covered with a waterproof membrane, which helps to protect the building from the elements. The District Administration Offices in Limassol are a prime example of mid-century modernist architecture, with a focus on functionality, efficiency, and simplicity. The building's use of reinforced concrete and precast concrete panels allowed for fast and efficient construction.

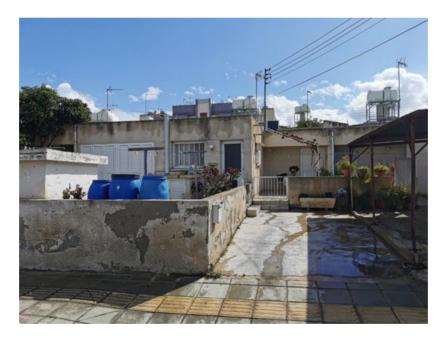
Figure 10: Typical residential refugee house (source, G. Xekalakis own work).

The residential refugee houses in Cyprus (Fig. **10**) in 1974 were characterized by their makeshift nature and lack of amenities. They were typically organized into small rooms or cubicles that were partitioned off using plywood or other materials. This type of building was usually constructed with walls that supported the weight of the roof and upper floors and rarely from columns and beams of low-strength concrete.

Following the Turkish invasion in 1974, there was a large population movement as refugees moved from the north to the southern part of the island which led to the development of low-quality settlements to house the displaced population. These settlements were often made up of casual structures, which were constructed quickly and with limited resources. These settlements varied in size and scope, from small encampments to large, sprawling communities. The construction of the casual structures in these settlements was often haphazard, with little attention paid to building codes or safety standards. Poor quality materials such as corrugated metal, plywood, and low classed of concrete were commonly used, while buildings were often constructed without proper foundations or structural support. This lack of oversight and quality control was particularly evident in buildings constructed in the rural and suburban areas of Cyprus, where construction standards were often lower than in the major urban centers. As a result, many buildings constructed during this period were vulnerable to structural problems such as cracking, settling, and collapse. This was particularly evident during earthquakes, which exposed the weaknesses in many buildings and resulted in significant damage and loss of life.
